GLASGOW BUCHANAN BUS STATION Interchange Audit

Susan Warren
Jolin Warren
6 March 2014

Linking cycling with
public transport

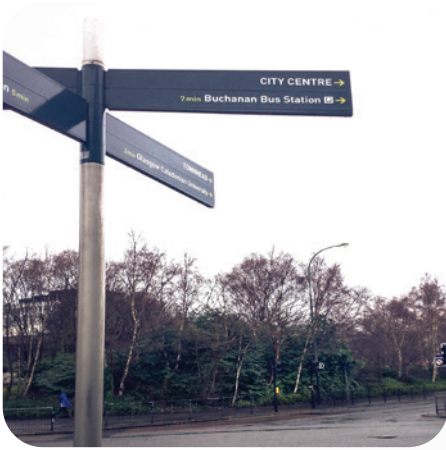
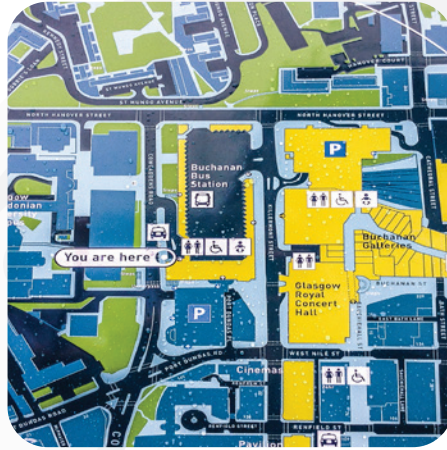
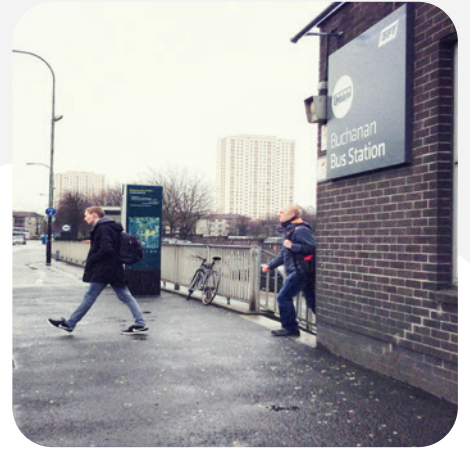
- ▶ There is no sign for the bus station at the sloping stairs opposite Glasgow Caledonian University which lead to the main station entrance, even though there are signs for Queen Street Railway Station and Buchanan Street.

- ▶ While there is a large station sign at the taxi and car waiting entrance, there is nothing for cyclists indicating whether they should enter with the taxis and cars or that this entrance leads directly to cycle parking.

- ▶ On the approach to the Cowcaddens Road entrance from North Hanover Street, there are pedestrian signs to the station but nothing to denote that a useful cycle entrance (with cycle parking) is just around the corner.

- ▶ At the West Nile Street/Port Dundas Road intersection with Cowcaddens Road, there was good signage to the bus station; there were also signs indicating that the pavement could be used by cyclists yet it was not clear at what point cyclists should switch from the road to the pavement.

- ▶ On the West Nile Street approach to Killermont Street, there is a sign for the bus station but no indication of whether this is an appropriate use or entrance for cyclists.
- ▶ At the intersection of West Nile Street and Killermont Street, it is clear that only taxis, buses and cyclists can turn down Killermont Street towards the station, but there are no street signs for the station; there is a pedestrian sign on the pavement, but this could be tricky to see from the road on a bicycle.
- ▶ On the North Hanover Street intersection with Killermont Street, there is a clear sign to Queen Street (rail) Station, but not to the bus station; this is despite part of the sign denoting a bus, taxi, and cyclist-only turning onto Killermont Street (towards the bus station).

With a more coherent approach to signage and some additional parking, cyclists would be well provided for at Buchanan Bus Station. A bit of investment could make a big difference.

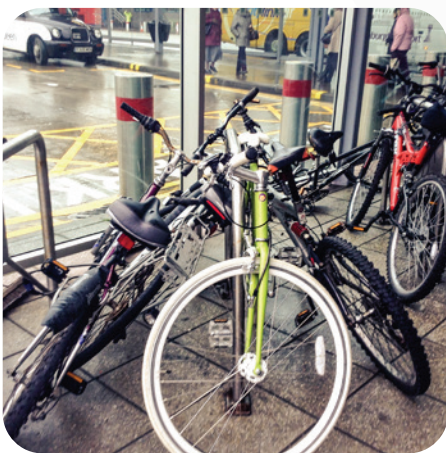
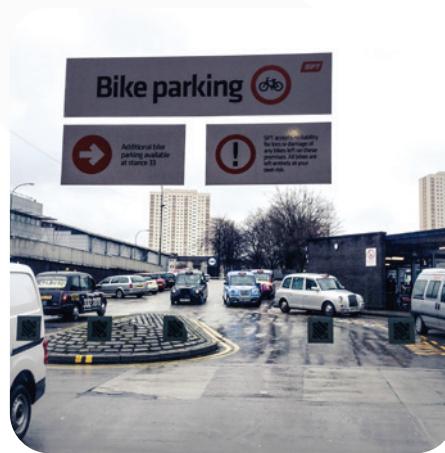
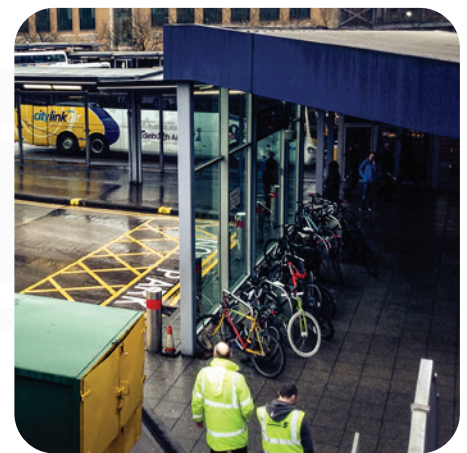
- ▶ Outside the main entrance, there is no outdoor cycle parking; there were two bikes locked to fencing around a tree (although this could have been people visiting shops or flats close by).

- ▶ While the main cycle parking area by stance 57 consists of well-spaced Sheffield stands which are covered with dedicated CCTV, the six stands provided are insufficient for demand; some stands had three bikes locked to them and one had four; additionally, even with the CCTV one bike had clearly been vandalised (it was missing a back wheel).
- ▶ There were 8 left locks at the main cycle parking area by stance 57 indicating that a rail for left locks would be of use.
- ▶ There is no cycle parking available on the side of the station along North Hanover Street (stances 24–32).
- ▶ Five new, well-spaced, clean, and covered Sheffield stands are provided near stance 33; however, only one bike and no left locks were present. This likely relates to the minimal signing for this parking.
- ▶ The parking near stance 33 does not have dedicated CCTV.
