## INVERNESS BUS STATION Interchange Audit

Linking cycling with  
public transport

### Purpose of the Interchange Audit

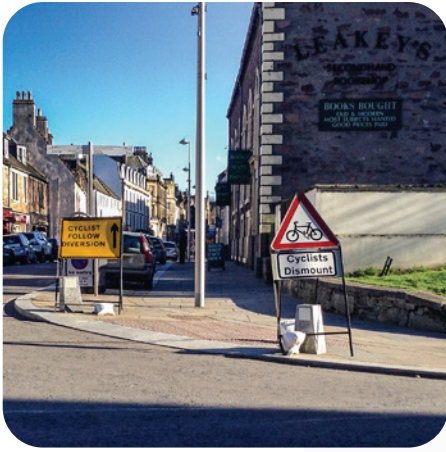
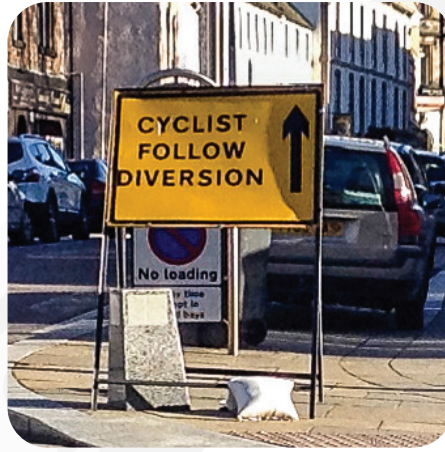
- ▶ At the bottom of Church Street there was a diversion which required cyclists to dismount and walk their bikes for a considerable distance. This was likely done because the road was one-way, but it would have been more useful to produce a diversion that allowed cyclists to stay on their bicycles. Rail and bus stations were signposted.
- ▶ Though there are several parking options around the bus station, there is no signage indicating its existence or location.
