INVERNESS RAILWAY STATION Interchange Audit

Linking cycling with
public transport

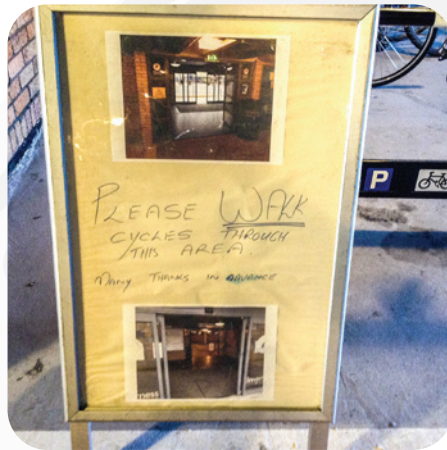
- ▶ The station entrance closest to Platform 1 (as well as along the fence running up to it) had signs stating that there was no cycling in the station and that bicycles could not be locked to the fence.

- ▶ Inside the railway station there were four cycle lockers on Platform 1 which were missed during the audit due to lack of signage.
- ▶ In Falcon Square there was a pedestrian sign for the railway station but no indication if this was a suitable route for a cyclist.

- ▶ At the north entrance it was unclear how a cyclist was meant to engage due to the lack of clarity offered by the signs in place. There were no drop kerbs, so engaging as a pedestrian with a bicycle (especially should one have loaded panniers) would have been difficult.
