interchange Audit Report

Bus Stations Audit Report

This report presents the findings of audits conducted at six bus stations across Scotland: Dundee, Edinburgh, Glasgow, Inverness, Perth, and Stirling. Additionally, findings for two other bus station audits – Aberdeen and Oban – are available in the *Sustainable Transport Hubs Audit Report*. www.transformsotland.org.uk/interchange

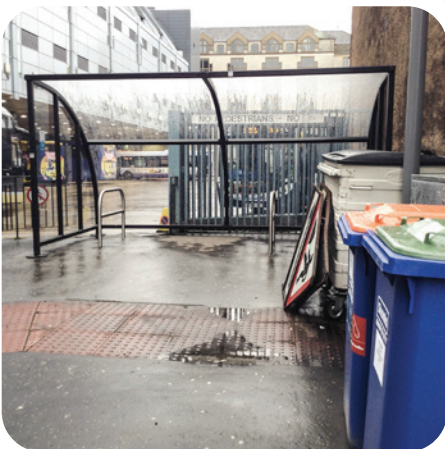
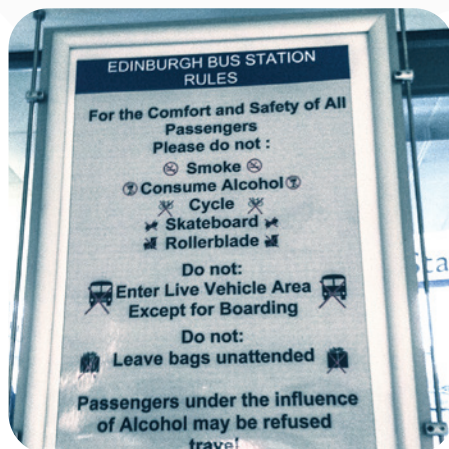
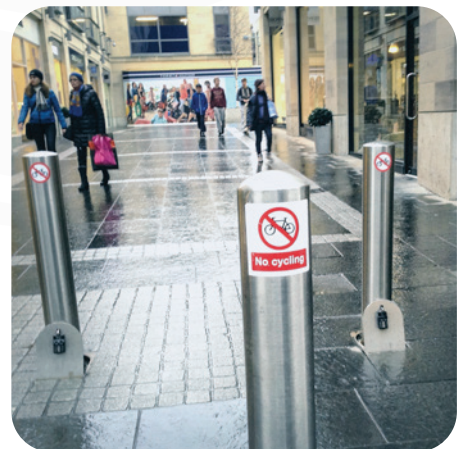
- ▶ When approaching the station from York Place, in either direction, there were no signs noting the need to turn up Elder Street to get to the bus station.

- ▶ There were a plethora of signs on either end of Multrees Walk stating cycling was not allowed. This is a 'private street' and so change will require coordination with the Multrees Walk owners.

- ▶ At the Elder Street entrance, there were four different signs for the bus station. However, there were no signs telling cyclists which routes were best for them to take, both in terms of entering the bus station or negotiating the area.

- ▶ When approaching from North Saint Andrew Street at York Place and Queen Street, there were no signs here for the bus station; there was a sign for National Cycle Route 75.

- ▶ Once at the entrances to the station, there were no signs directing you to the cycle parking, but the parking area had just been installed a few days previous to the audit.

- ▶ There was clear signage that cycling in the station was not permitted.

The signage to the bus station from all approaches requires attention, both in terms of finding the station but also ensuring cyclists know that the Elder Street entrance has cycle parking. As seen in many of the audits, there were plenty of signs telling cyclists where not to go but few positive signs for routes and cycle parking.

Signage was the main concern at this station and could be fixed relatively easily with some thought given to providing consistent, useful signage for cyclists. Knowing how to reach the station by the best route and where the cycle parking is located will make the most of a station which is otherwise well suited to being accessed by bicycle.

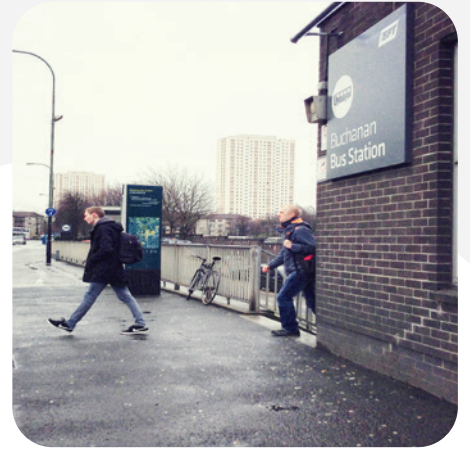
- ▶ There is no sign for the bus station at the sloping stairs opposite Glasgow Caledonian University which lead to the main station entrance, even though there are signs for Queen Street Railway Station and Buchanan Street.

- ▶ While there is a large station sign at the taxi and car waiting entrance, there is nothing for cyclists indicating whether they should enter with the taxis and cars or that this entrance leads directly to cycle parking.

- ▶ On the approach to the Cowcaddens Road entrance from North Hanover Street, there are pedestrian signs to the station but nothing to denote that a useful cycle entrance (with cycle parking) is just around the corner.

- ▶ At the West Nile Street/Port Dundas Road intersection with Cowcaddens Road, there was good signage to the bus station; there were also signs indicating that the pavement could be used by cyclists yet it was not clear at what point cyclists should switch from the road to the pavement.

- ▶ On the West Nile Street approach to Killermont Street, there is a sign for the bus station but no indication of whether this is an appropriate use or entrance for cyclists.
- ▶ At the intersection of West Nile Street and Killermont Street, it is clear that only taxis, buses and cyclists can turn down Killermont Street towards the station, but there are no street signs for the station; there is a pedestrian sign on the pavement, but this could be tricky to see from the road on a bicycle.
- ▶ On the North Hanover Street intersection with Killermont Street, there is a clear sign to Queen Street (rail) Station, but not to the bus station; this is despite part of the sign denoting a bus, taxi, and cyclist-only turning onto Killermont Street (towards the bus station).

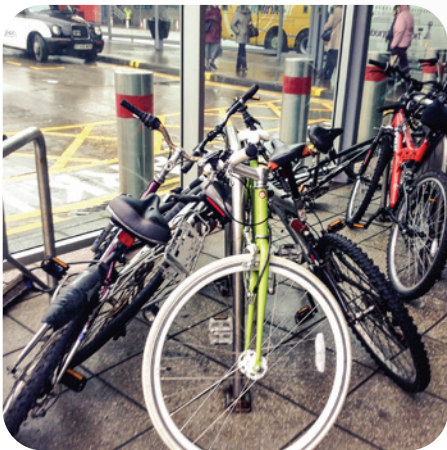
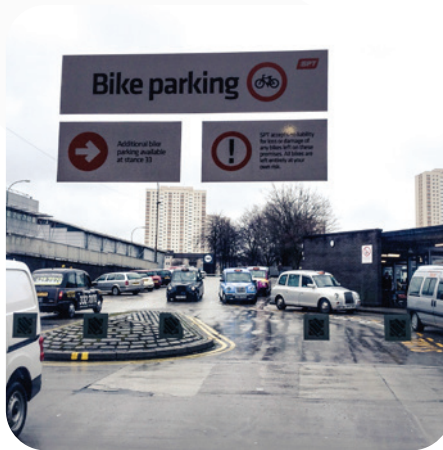
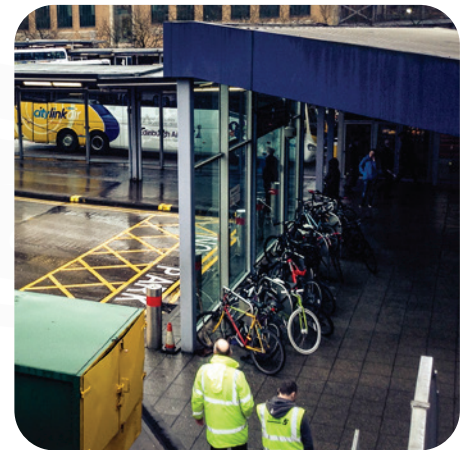
- ▶ Outside the main entrance, there is no outdoor cycle parking; there were two bikes locked to fencing around a tree (although this could have been people visiting shops or flats close by).

- ▶ While the main cycle parking area by stance 57 consists of well-spaced Sheffield stands which are covered with dedicated CCTV, the six stands provided are insufficient for demand; some stands had three bikes locked to them and one had four; additionally, even with the CCTV one bike had clearly been vandalised (it was missing a back wheel).
- ▶ There were 8 left locks at the main cycle parking area by stance 57 indicating that a rail for left locks would be of use.
- ▶ There is no cycle parking available on the side of the station along North Hanover Street (stances 24–32).
- ▶ Five new, well-spaced, clean, and covered Sheffield stands are provided near stance 33; however, only one bike and no left locks were present. This likely relates to the minimal signing for this parking.
- ▶ The parking near stance 33 does not have dedicated CCTV.

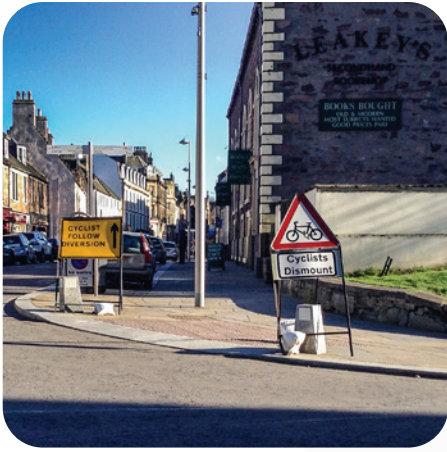
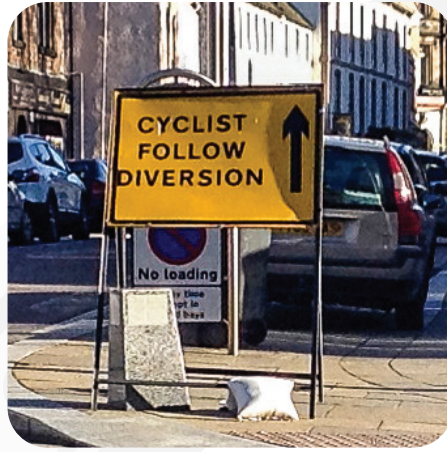
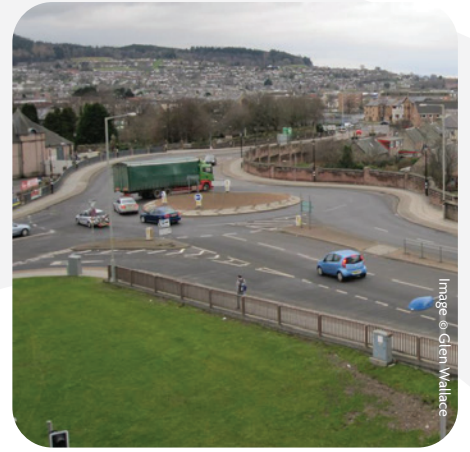
- ▶ At the bottom of Church Street there was a diversion which required cyclists to dismount and walk their bikes for a considerable distance. This was likely done because the road was one-way, but it would have been more useful to produce a diversion that allowed cyclists to stay on their bicycles. Rail and bus stations were signposted.
- ▶ Though there are several parking options around the bus station, there is no signage indicating its existence or location.

- ▶ The Inverness Bus Station provided no parking but there were a few locations very nearby which are covered below.
- ▶ At the Inverness Library, behind the bus stances, there were 3 uncovered Sheffield stands which were installed too close to the building to be used properly. There was no CCTV but some natural surveillance.

- ▶ In the Rose Street multi-story car park, at the ground level close to the bus station, was a covered area of cycle parking with 14 Sheffield stands. The spacing was very good and CCTV was present. 10 bicycles were parked here – four looked like they had been there for a very long time and one was clearly abandoned. There were several left locks. This area used to be parking for a bicycle hire scheme which no longer exists.

- ▶ Outside the Spectrum Centre, just north of the bus station, there were three Sheffield stands which were installed too close to the wall. These were not covered and had no CCTV. Natural surveillance was satisfactory, at least at the time of the audit, but it was difficult to know what this would be like in the evening or after dark.

Cycle parking was a big problem at Inverness Bus Station as none was provided by the station and there was no signage to the cycle parking provided nearby by other facilities. The nearby cycle parking was also of variable quality, with only one location providing properly-spaced, covered parking. And there was a lack of parking right next to the station for those wishing to lock up their bicycle to buy tickets or use the café.

The other key issue that needs to be addressed is the northern approach along Longman Road which had fast and dangerous traffic. This will require infrastructure in the form of a specific segregated or alternate cycle route to provide a safe way to access the station when coming from or going to the north.
