interchange Audit Report

ScotRail Stations Audit Report

This report presents the findings of audits conducted at four ScotRail managed railway stations: Fort William, Inverness, Perth, and Stirling. Additionally, findings for three other ScotRail station audits—Aberdeen, Mallaig, and Oban—are available in the *Sustainable Transport Hubs Audit Report*. And due to the size and complexity of Edinburgh Waverley railway station, its findings are presented in the separate *Edinburgh Waverley Audit Report*. www.transformscotland.org.uk/interchange

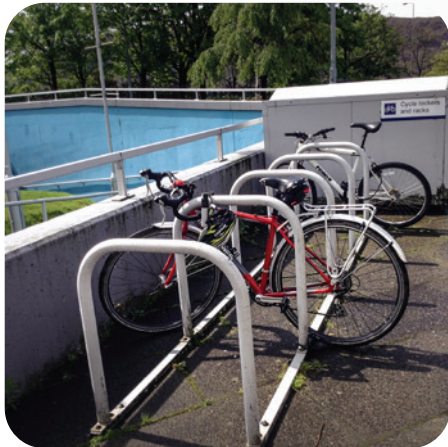
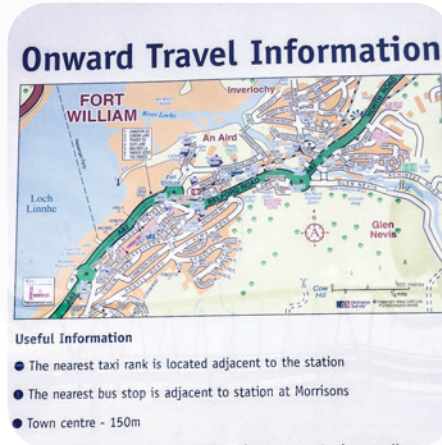
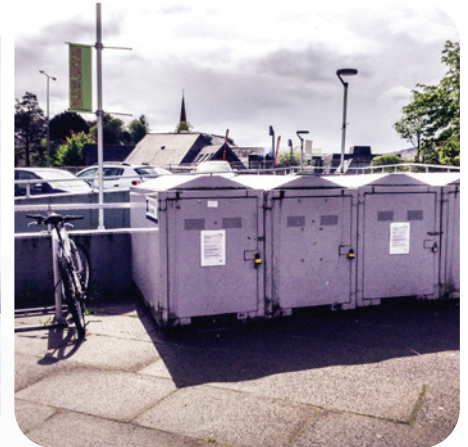
- ▶ All station approaches were well signposted.
- ▶ There were maps and details of local cycle routes available outside the station.

- ▶ There were four bicycle lockers in need of a clean, but clearly in use and otherwise well maintained. All were locked on Sunday, despite there being a notice that they were not for long term use. Three contained bicycles. There were also five Sheffield stands, uncovered with good spacing, good natural surveillance and CCTV coverage. There was one abandoned bicycle attached to the stands and one left lock.

- ▶ The entrances to the station had automatic doors which made entering easy with a bicycle.
- ▶ There were also automatic doors between the main concourse and the platforms.

- ▶ There was a large waiting area with plenty of space for bicycles in the station. Access to the ticket desk was easy, natural surveillance and CCTV plentiful so it was easy to set a bicycle on the side walls if needed in order to purchase tickets.
- ▶ The following were available: showers, lockers, toilets, café. (For the café and showers, bicycles were best left outside station in parking area.)

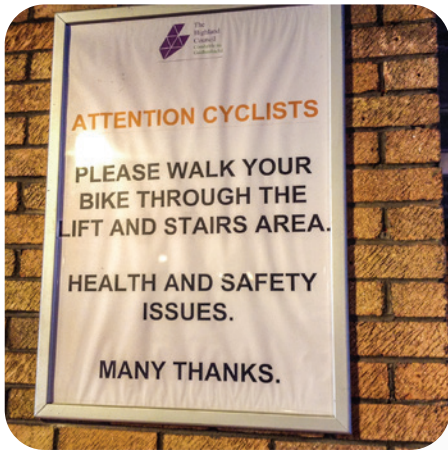
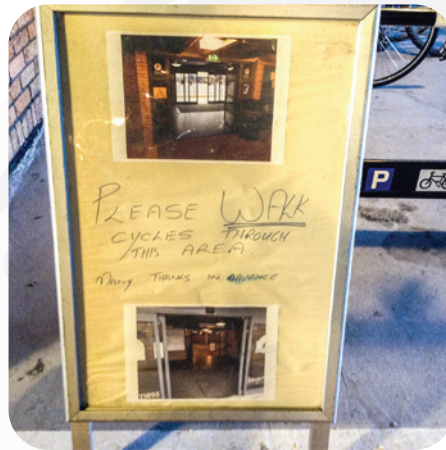
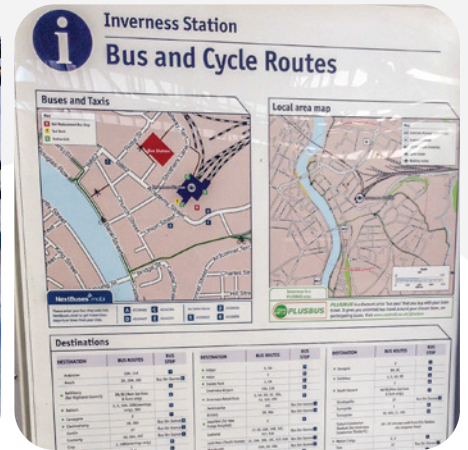
- ▶ The station entrance closest to Platform 1 (as well as along the fence running up to it) had signs stating that there was no cycling in the station and that bicycles could not be locked to the fence.

- ▶ Inside the railway station there were four cycle lockers on Platform 1 which were missed during the audit due to lack of signage.
- ▶ In Falcon Square there was a pedestrian sign for the railway station but no indication if this was a suitable route for a cyclist.

- ▶ At the north entrance it was unclear how a cyclist was meant to engage due to the lack of clarity offered by the signs in place. There were no drop kerbs, so engaging as a pedestrian with a bicycle (especially should one have loaded panniers) would have been difficult.

- ▶ At Longman Road (A82) and the Rose Street Roundabout there were no signs to the railway station.
- ▶ Heading west on Longman Road (A82) towards Fort William (the 'Tourist Route to the North and West') there were no signs to the railway station at the Rose Street Roundabout.

- ▶ At the railway station, while there was a local information map on a poster near the lockers it gave no indication of how to get onto National Cycle Route 1 or National Cycle Route 7, despite both being nearby.

- ▶ At the bottom of Church Street there was a diversion which required cyclists to dismount and walk their bicycles for a considerable distance. This was likely done because the road was one way, and whilst rail and bus stations were signposted, it would have been more useful to produce a diversion that allowed cyclists to stay on their bicycles.

- ▶ There are four bicycle lockers on Platform 1 which are not signed at all. They were completely missed during the on-the-ground audit, and only came to light when speaking with staff in the central office during the review of CCTV coverage.

- ▶ There was public and staff cycle parking close to the Platform 1 entrance. For the public, there were five Sheffield stands under cover and in full use. There was generally good natural surveillance and while CCTV was present, it only covered the staff parking area which was also gated and locked.
- ▶ At the north entrance there were two sections of parking. The first upon leaving the station was a shelter with 10 spaces in principle, although it would be very difficult to get 10 bicycles into this space, given how close together the spaces were located. Seven of the covered spaces were occupied and one bicycle was chained to the side of the shelter.

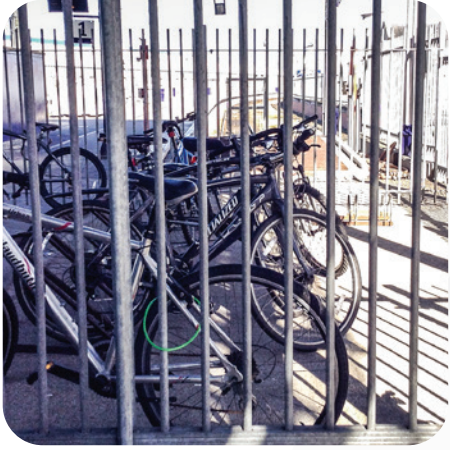
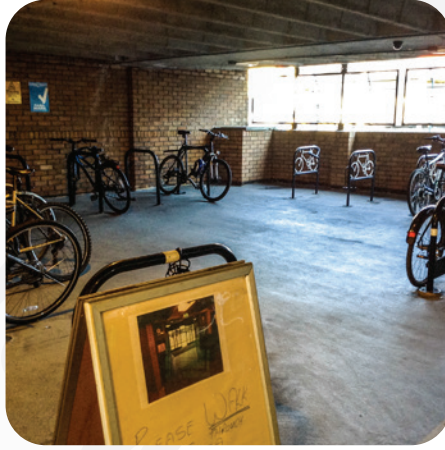
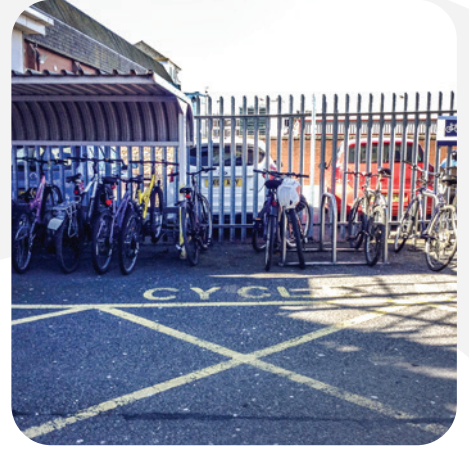
- ▶ There were also 11 Sheffield stands with 11 bicycles parked at them. These Sheffield stands were not spaced far enough apart, the narrowest being 54cm and the widest space being 80cm (the ideal is 100cm, which ensures each Sheffield stand can easily take 2 bicycles). This area was uncovered. The view offered by CCTV of the parking area was observed in the station office and it was not ideal as it was some distance from the stands. It could be improved by repositioning the camera.
- ▶ Inside the railway station there were four cycle lockers on Platform 1 which were only discovered while talking to staff during the CCTV review at the central office. The lockers had excellent CCTV coverage. According to staff, they require the user to provide their own padlock and were rarely used.

- ▶ At the junction of Longman Road and the Rose Street Roundabout the traffic was heavy and fast, making it quite difficult for anyone but the most competent and confident of cyclists to manoeuvre. Even then, their safety could be compromised by how drivers behave on this section of road. This was the main route from the north to the railway station (and city centre and bus station) and from the railway station to the north.

- ▶ In the railway station there were left luggage lockers and showers available.
- ▶ Cyclists could take their bicycles into the railway station with them to purchase tickets. Some chose on the day to leave their bicycles outside leaning against the glass of the ticket office, unlocked. It would be possible to take a bicycle in to the cafe, as there was sufficient space inside. The WH Smith in the station was too small to take a bicycle and using this store would require locking up one's bicycle or leaving it outside the shop.

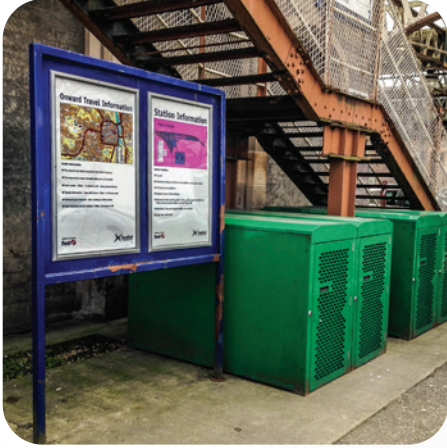
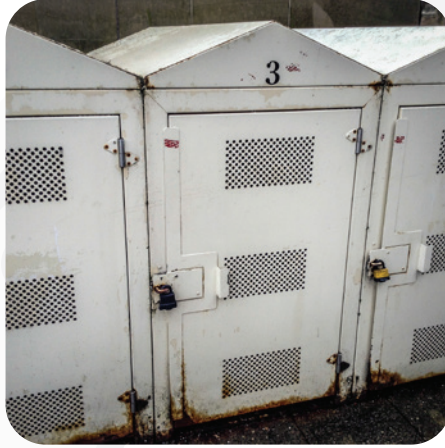
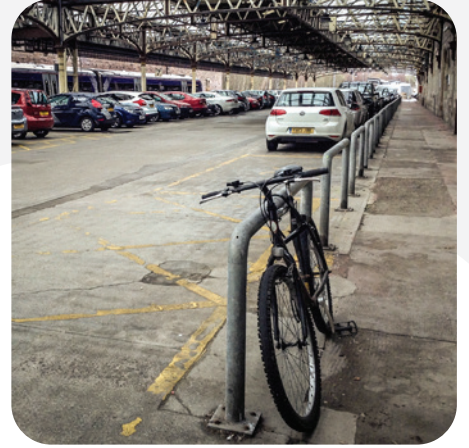
- ▶ The York Place entrance had signs showing that the entrance was for bicycles, however the entrance ramp at platforms 5, 6, and 7 were nowhere near the main station building with the ticket office, café, and toilets.

- ▶ Along the second part of the York Place entrance drive, there were bollards shaped like Sheffield stands, however there were no signs indicating whether these could be used for cycle parking or not. People were using them for parking, but it was not clear if this was station policy or simply tolerated.

- ▶ The official cycle parking at the bottom of the first part of the York Place entrance ramp was not signed and was hidden behind parked cars.
- ▶ There was a sign on Caledonian Road pointing towards the general area of the main rail station entrance and the bus station, however when following the road around to St Andrews Street and then reaching the intersection with Leonard Street, there was no sign indicating which way to turn.

- ▶ There were no signs in the station indicating whether you can cycle in the station or not (and there was a lot of space in the station, and wide ramps, so it might seem like a good place to cycle).
- ▶ While all platforms could be accessed by lifts or wide ramps and bridges, platforms at the station are extremely long and this can cause a problem when short trains arrive and cyclists are a long way off from where they need to be to store their bike on the train.

- ▶ At the main exit (onto Leonard Street), there was a sign for the bus station but none for cycles routes to the city centre or the wider area.

- ▶ On the left side of the main entrance (off Leonard Street) there were four Sheffield stands but they were uncovered and exposed to the weather. However natural surveillance was good in times of regular traffic and daylight.

- ▶ While CCTV was present outside the main entrance, it was not clear if it covered the Sheffield stands.
- ▶ On the right side of the main entrance (off Leonard Street) there were five cycle lockers. All had locks on them, some in better shape than others and three contained bicycles; the lockers did not appear well maintained and there was no information on how to reserve one. It appeared as if individuals had claimed the lockers for their own long term use with a lock, and there was nothing to prevent this.

- ▶ The York Place entrance had plenty of parking at the bottom of the first part of the ramp, though it was hidden behind parked cars and not visible from inside the station, so could be a security concern due to the low level of natural surveillance.

- ▶ Lockers were available at the bottom of the first part of the York Place entrance ramp, but they have integral locks and require a key and no information was provided on how to get one. This is despite the presence of information boards right next to the lockers.

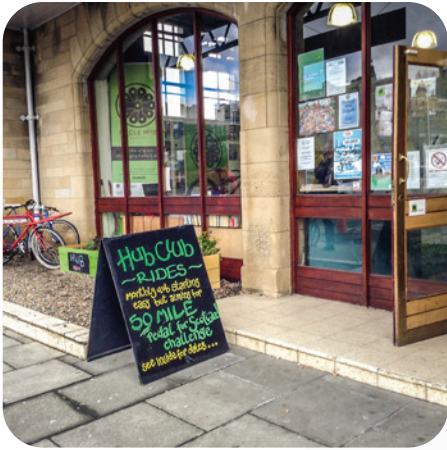
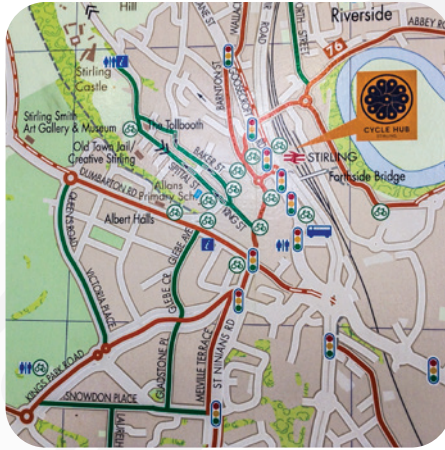
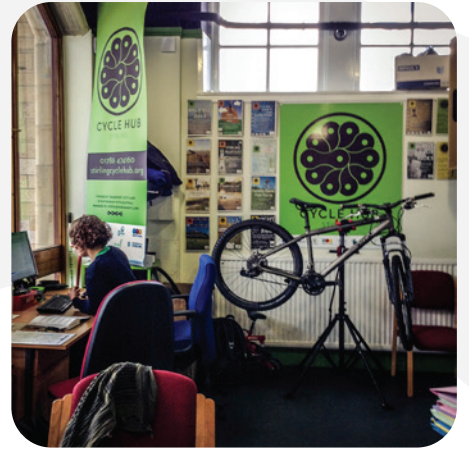
- ▶ There was no sign directing cyclists to the cycle hub from inside the station or on any of the station approaches.
- ▶ There were no signs outside or inside the station directing cyclists to the parking areas.
- ▶ The through platforms were very long and it could be difficult to know where a train is going to stop. Having signs or markings where trains stop for different services would be useful in these circumstances.

- ▶ On the north side of the station, there were 4 covered Sheffield stands which were over capacity with 9 bicycles. The natural surveillance in this area was poor. The CCTV was old and not pointing in the correct direction.

- ▶ In the same area as the above Sheffield stands were 20 bicycle lockers, 19 of which were in use.
- ▶ Beyond the lockers were four further uncovered Sheffield stands with 3 bicycles parked. The natural surveillance and CCTV were extremely poor. This area had a fair amount of rubbish and 3 broken locks.

- ▶ Access to the northern parking area was close to and blocked by the taxis rank. Local cyclists found this was a problem.
- ▶ In front of the station, off to the south were four Sheffield stands with five bicycles on them. There were also four bicycles attached to the railings in the same area. There was no CCTV but the area did have a good level of natural surveillance.

- ▶ There was no direct route for cyclists to enter the station and therefore the tendency was for cyclists to get onto the pavement in front of the station, which could cause congestion.

- ▶ There was one large automatic ticket gate which was suitable for cyclists.
- ▶ The ticket barrier was well staffed.
- ▶ Access to Platform 2 was level and therefore easily manoeuvred with a bicycle.

- ▶ Platforms 3–8 required stairs and/or using lifts. None of the stairs had wheel wells. Lifts to the footbridge and to Platforms 3–8 both had a ramp with a railing to enter or exit the lift and this made space very tight. The space would be impossible to manoeuvre should anyone be waiting for the lift with large luggage or in a wheelchair.

- ▶ Platforms 9 & 10 were accessed from the main foot bridge, but required one to go down a few stairs, then back up to cross the footbridge. There were no lifts to Platforms 9 & 10. There were no lifts for lifts to be installed.
